# Ames Avenue Safe Mobility Recovery Plan

### NEEDS ASSESSMENT REPORT

Prepared for:  
City of Omaha – Public Works Department

Prepared by:  
WSP USA, Inc

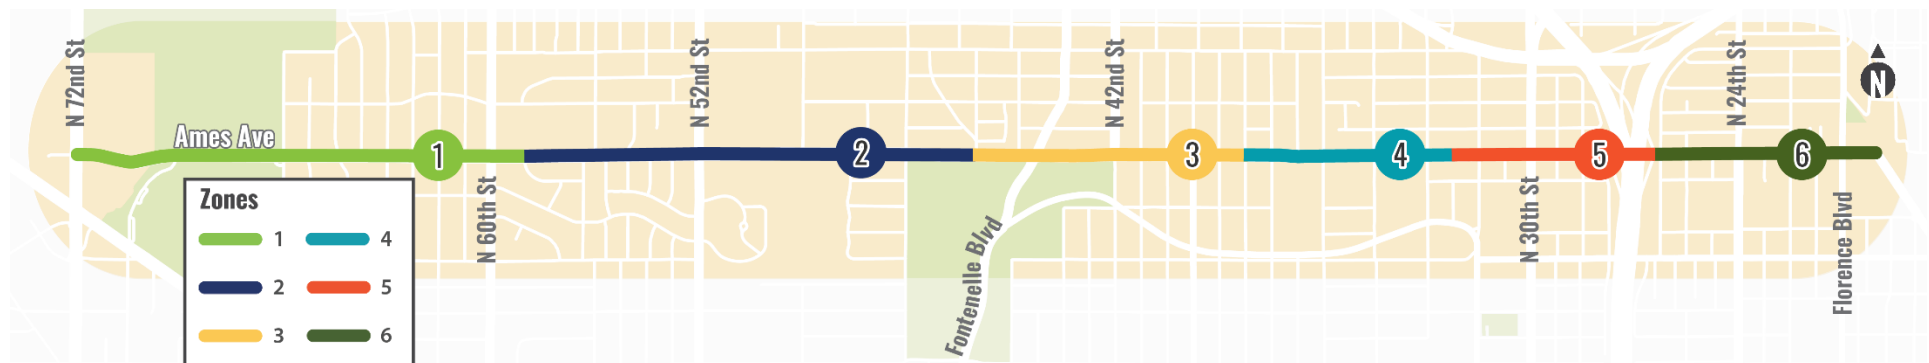
Figure 1: Ames Avenue Study Area

The study area consists of a 4.25-mile section of Ames Avenue between N. 72<sup>nd</sup> Street and Florence Boulevard (**Figure 1**). The Ames Avenue corridor is an east-west arterial roadway of the National Highway System, serving as a major east-west corridor in the City of Omaha; this corridor connects the North Freeway (US-75) to N. 72<sup>nd</sup> Street and provides access to important community institutions like North High School, Skinner Elementary, the NorthStar Foundation, Fontenelle Park, and many local businesses. Ames Avenue is a significant economic corridor for the community and needs to serve the residents, workers, and visitors of the area. For purposes of the Needs Assessment, the corridor was divided into six “Zones” as shown in Figure 1.

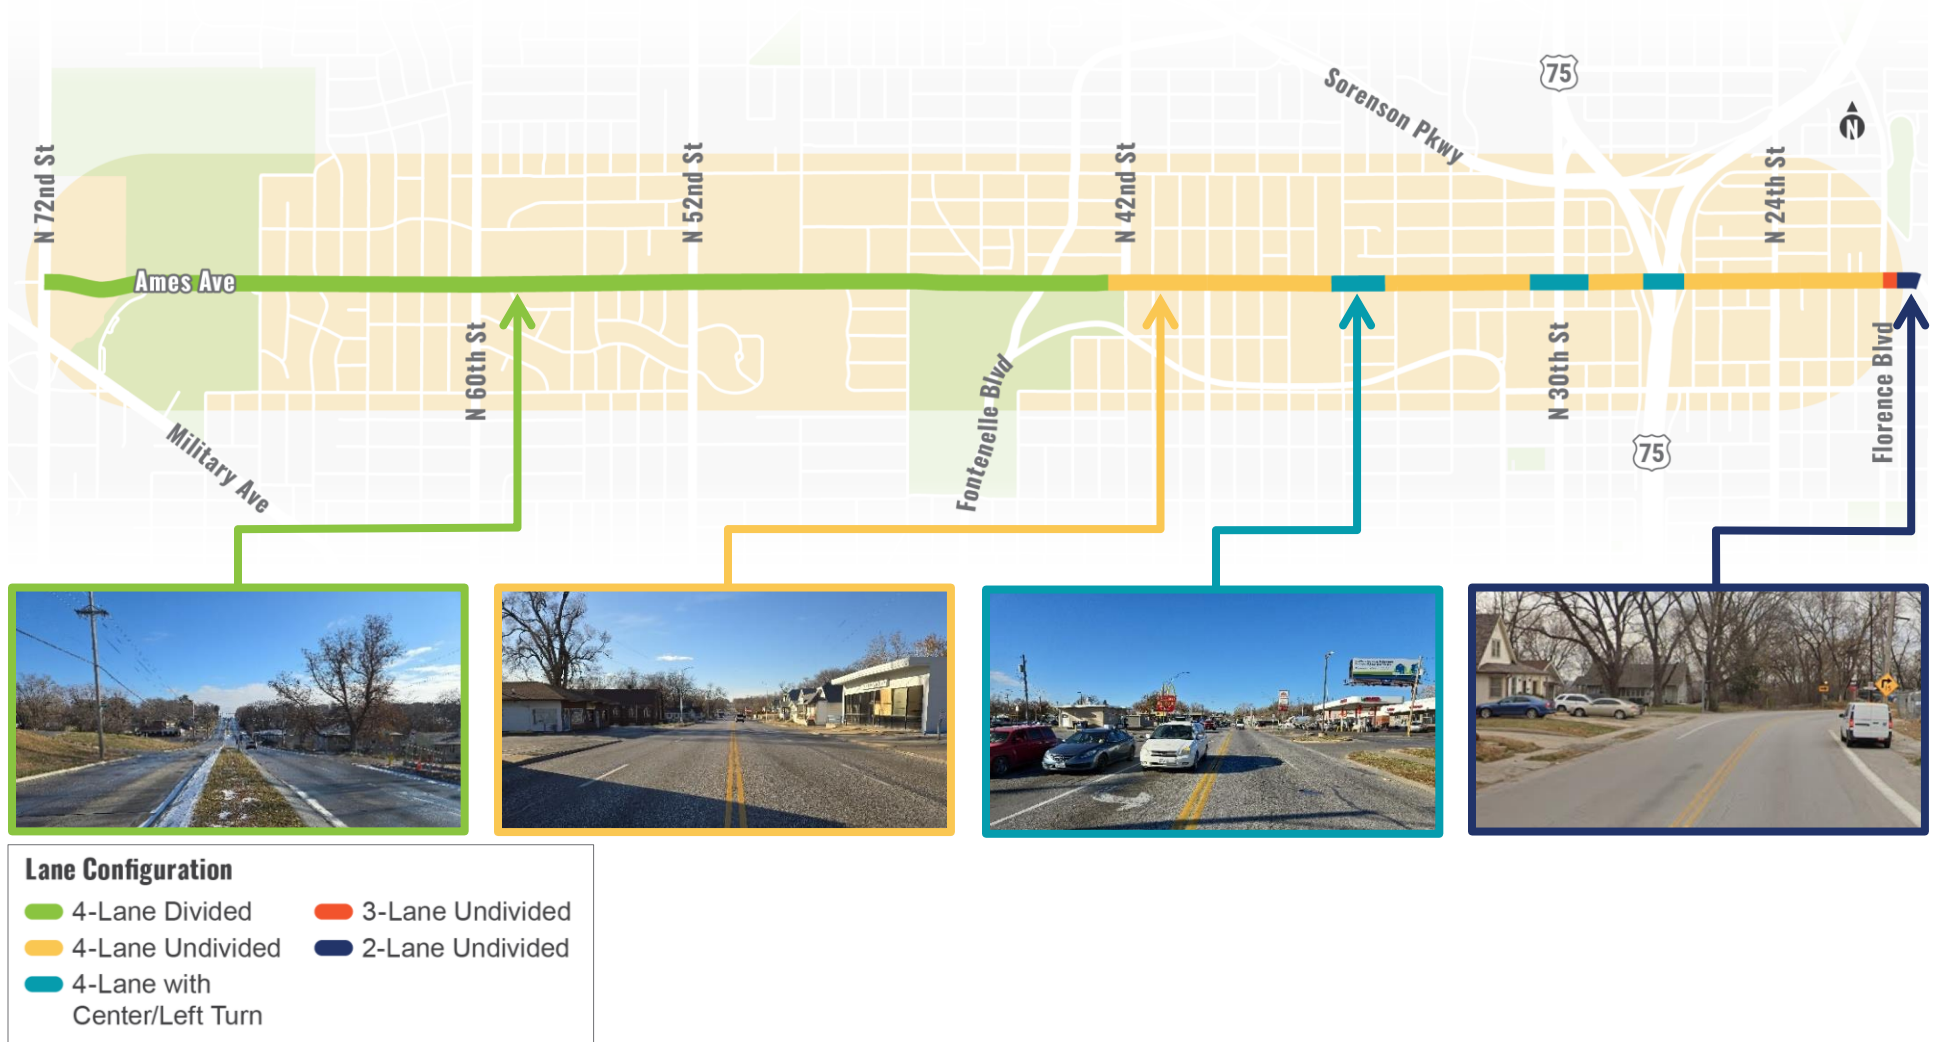
Figure 2: Existing Typical Lane Configurations

Approximately 98% of the Ames Avenue corridor is four through lanes wide (**Figure 2**). Between N. 72<sup>nd</sup> Street and N. 42<sup>nd</sup> Street, Ames Avenue is a four-lane divided roadway; between N. 42<sup>nd</sup> Street and N. Florence Boulevard, Ames Avenue is either a four-lane undivided or four-lane roadway with a center/left-turn lane. Approximately 2% of Ames (from N. Florence Boulevard onwards, heading east) is an undivided three-lane or two-lane section.

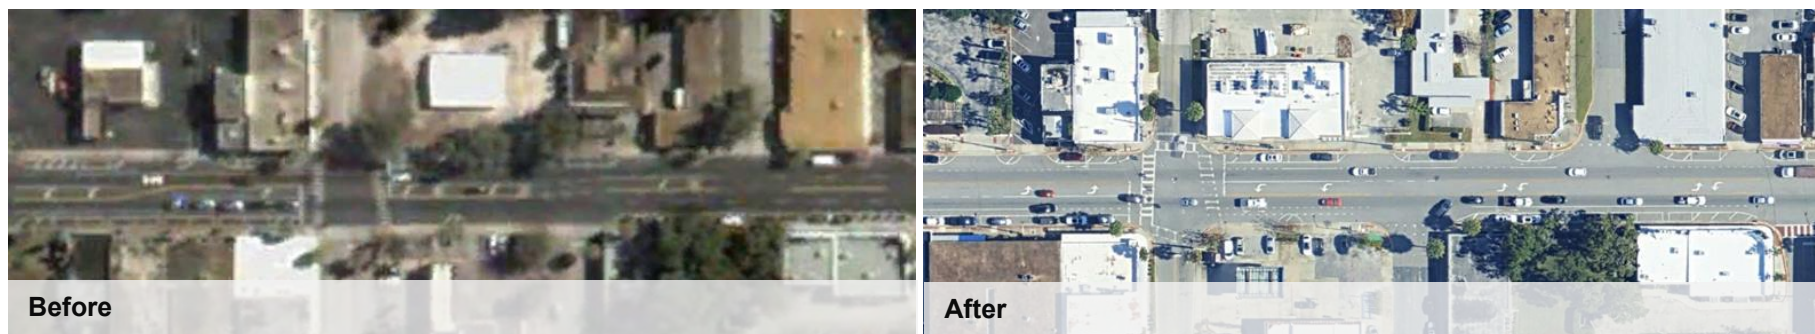
**Figure 7: Edgewater Drive Before and After Lane Reconfiguration**

Additionally, six case studies across the US (in Florida, North Carolina, Colorado, California, Minnesota, and New York) were reviewed to understand how multimodal safety improvements influenced travel behavior, supported local businesses, and enhanced community vitality. For example, Edgewater Drive in Orlando, Florida, was reconfigured from four lanes to three lanes and shared many similar characteristics with Ames Avenue (Figure 7). From 2008 to 2016, after the reconfiguration, the property values adjacent to Edgewater Drive and within a half mile of the corridor rose 80% and 70%, respectively.
